Khalida Khan<sup>(1)</sup>, Ashraf C.M<sup>(2)</sup>, Rabia Faridi<sup>(3)</sup>

## CLIMATE CHANGE EFFECT ON THE HUNZA LAKE AND GEOMORPHOLOGIC STATUS OF THE HUNZA RIVER BASIN, GILGIT-BALTISTAN, PAKISTAN

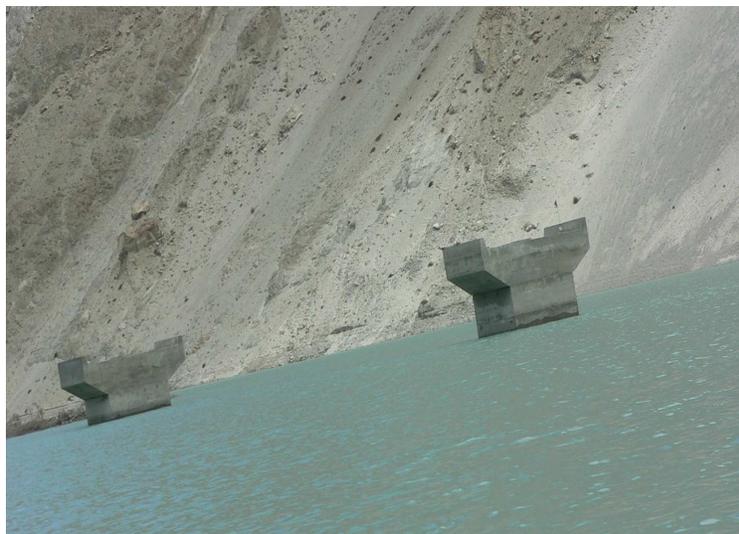
Figure 2 The lake formed by the landslide is now about 25km long 358ft deep and rising gradually. Newly under construction bridge by the Chinese Engineers also went under water.

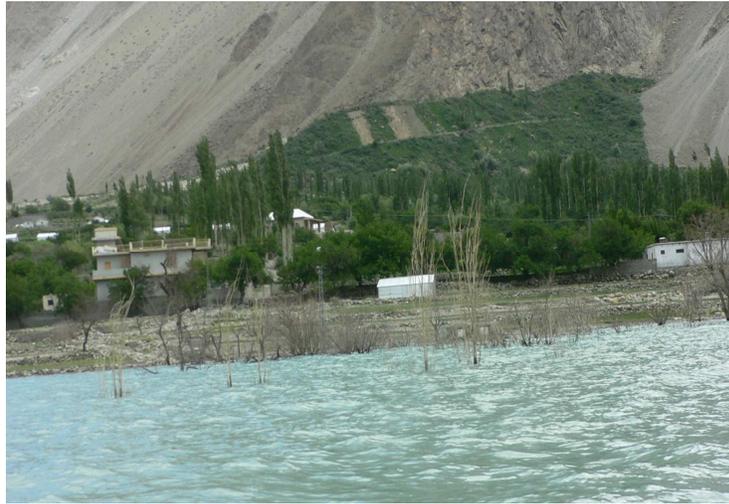
Figure 3 Author witnessed on 6th of June, 2011, a productive part of Gulmit, Shishkat, Shishkat Bridge Ayyain abad Attabad (almost wiped out). Communities are still waiting for support.

Figure 5 Latest satellite spot image of Attabad lake, Hunza Nagar, Gigit-Baltistan supports figure 3

Initially, the discharge rate of flow was increasing up to 6th June, 2010 and remained almost stationary till 11th June then it again started rising up till 18th of June 2010. Due to rise in temperature, the channel widening continued which would be evident from the recently taken photograph of this channel on 4th of June, 2011 (Fig.3).

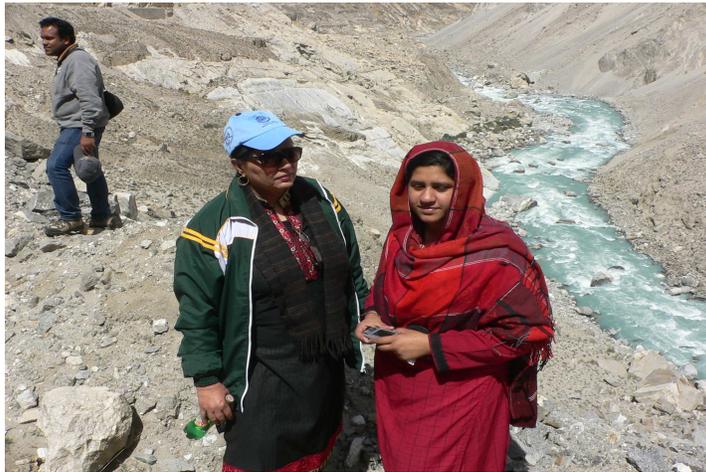
Figure 4 During field study on 8th June, spillway photograph of the Attabad Lake and the surrounding area shows morphology

A spillway was also built by army engineers who diverted water to its old route winding into the Gilgit River. Up till now the Lake has not been drained successfully as recently witnessed by the authors (Fig.4). A recent field study
